Administrative Order CWA-03-2009-0313DN

Five-Year Summary of Activities

Respondent: **Hanover Township/City of Allentown Sewer**

**HANOVER TOWNSHIP, LEHIGH COUNTY
 ALLENTOWN SANITARY SEWER SYSTEM**
 LMK KRS SCALE: 1" = 150' FEBRUARY 4, 2011
 REVISED 8-27-14

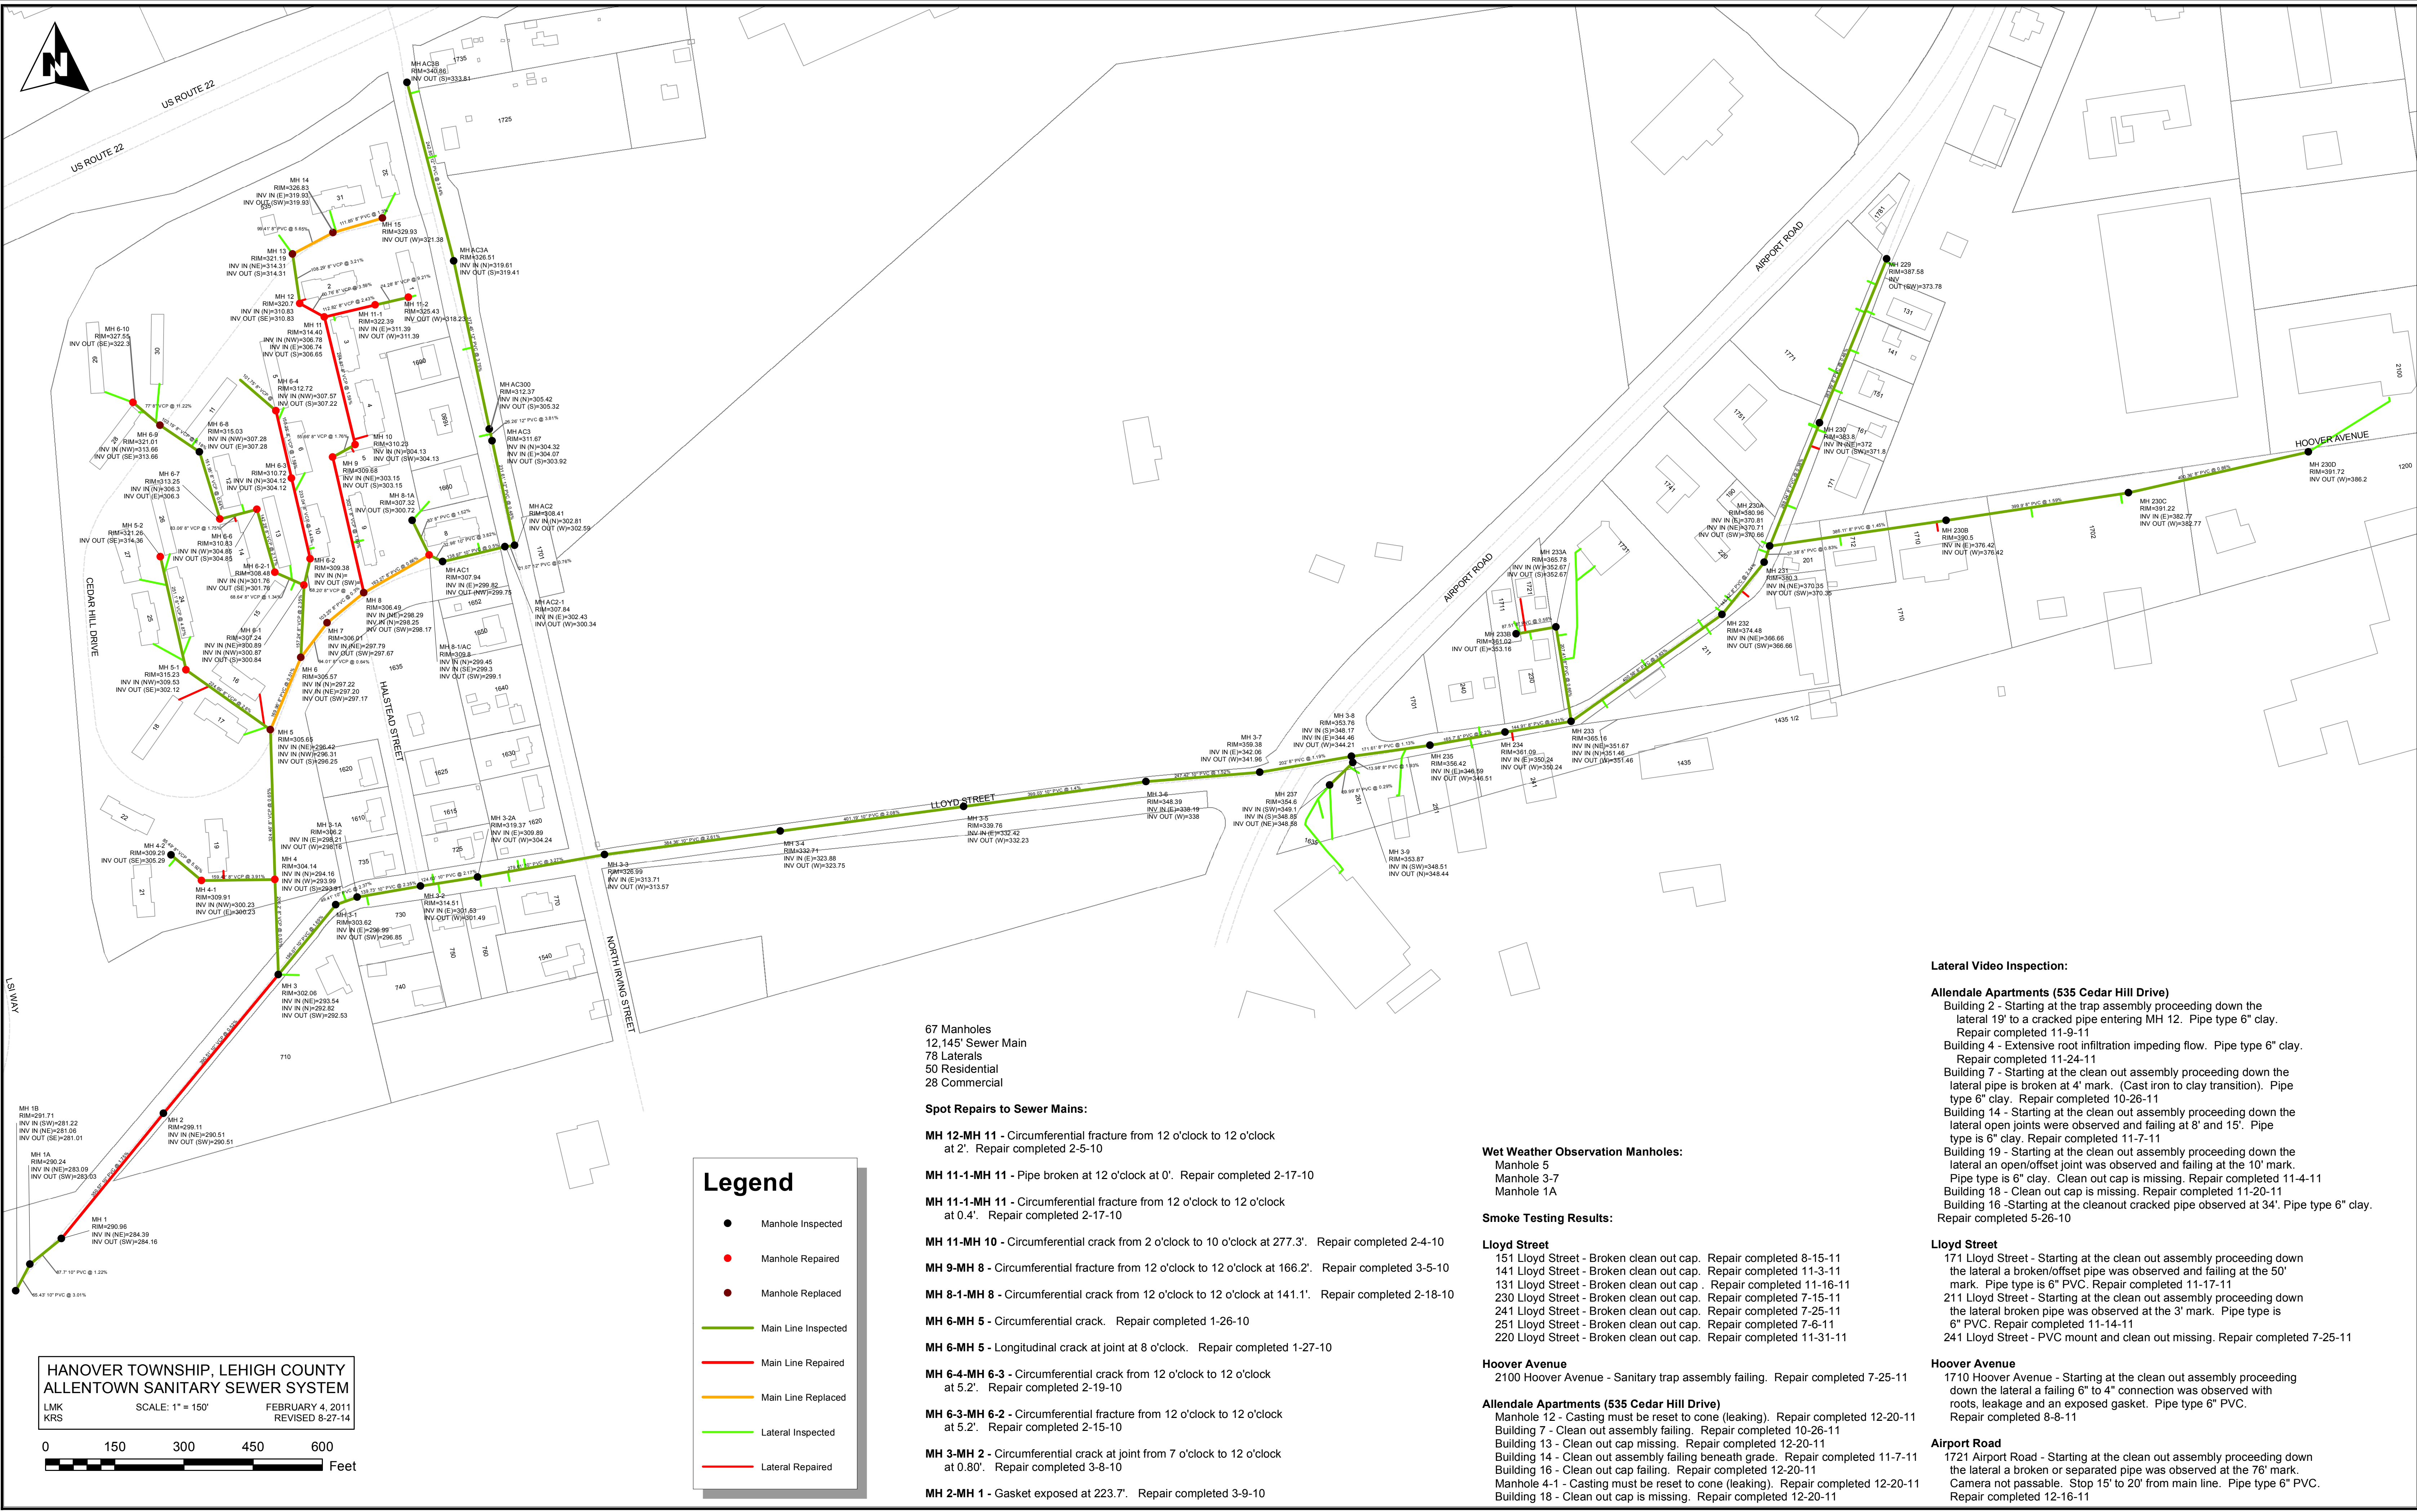
67 Manholes
 12,145' Sewer Main
 78 Laterals
 50 Residential
 28 Commercial

Spot Repairs to Sewer Mains:

- MH 12-MH 11** - Circumferential fracture from 12 o'clock to 12 o'clock at 2'. Repair completed 2-5-10
- MH 11-1-MH 11** - Pipe broken at 12 o'clock at 0'. Repair completed 2-17-10

- MH 11-1-MH 11** - Circumferential fracture from 12 o'clock to 12 o'clock at 0.4'. Repair completed 2-17-10
- MH 11-MH 10** - Circumferential crack from 2 o'clock to 10 o'clock at 277.3'. Repair completed 2-4-10

- MH 9-MH 8** - Circumferential fracture from 12 o'clock to 12 o'clock at 166.2'. Repair completed 3-5-10
- MH 8-1-MH 8** - Circumferential crack from 12 o'clock to 12 o'clock at 141.1'. Repair completed 2-18-10

- MH 6-MH 5** - Circumferential crack. Repair completed 1-26-10
- MH 6-MH 5** - Longitudinal crack at joint at 8 o'clock. Repair completed 1-27-10
- MH 6-4-MH 6-3** - Circumferential crack from 12 o'clock to 12 o'clock at 5.2'. Repair completed 2-19-10

- MH 6-3-MH 6-2** - Circumferential fracture from 12 o'clock to 12 o'clock at 5.2'. Repair completed 2-15-10
- MH 3-MH 2** - Circumferential crack at joint from 7 o'clock to 12 o'clock at 0.80'. Repair completed 3-8-10

- MH 2-MH 1** - Gasket exposed at 223.7'. Repair completed 3-9-10

Smoke Testing Results:

- Lloyd Street**
- 151 Lloyd Street - Broken clean out cap. Repair completed 8-15-11
 - 141 Lloyd Street - Broken clean out cap. Repair completed 11-3-11
 - 131 Lloyd Street - Broken clean out cap. Repair completed 11-16-11
 - 230 Lloyd Street - Broken clean out cap. Repair completed 7-15-11
 - 241 Lloyd Street - Broken clean out cap. Repair completed 7-25-11
 - 251 Lloyd Street - Broken clean out cap. Repair completed 7-6-11
 - 220 Lloyd Street - Broken clean out cap. Repair completed 11-31-11

- Hoover Avenue**
- 2100 Hoover Avenue - Sanitary trap assembly failing. Repair completed 7-25-11

- Allendale Apartments (535 Cedar Hill Drive)**
- Manhole 12 - Casting must be reset to cone (leaking). Repair completed 12-20-11
 - Building 7 - Clean out assembly failing. Repair completed 10-26-11
 - Building 13 - Clean out cap missing. Repair completed 12-20-11
 - Building 14 - Clean out assembly failing beneath grade. Repair completed 11-7-11
 - Building 16 - Clean out cap failing. Repair completed 12-20-11
 - Manhole 4-1 - Casting must be reset to cone (leaking). Repair completed 12-20-11
 - Building 18 - Clean out cap is missing. Repair completed 12-20-11

Lateral Video Inspection:

- Allendale Apartments (535 Cedar Hill Drive)**
- Building 2 - Starting at the trap assembly proceeding down the lateral 19' to a cracked pipe entering MH 12. Pipe type 6" clay. Repair completed 11-9-11

- Building 4 - Extensive root infiltration impeding flow. Pipe type 6" clay. Repair completed 11-24-11
 - Building 7 - Starting at the clean out assembly proceeding down the lateral pipe is broken at 4' mark. (Cast iron to clay transition). Pipe type 6" clay. Repair completed 10-26-11

- Building 14 - Starting at the clean out assembly proceeding down the lateral open joints were observed and failing at 8' and 15'. Pipe type is 6" clay. Repair completed 11-7-11

- Building 19 - Starting at the clean out assembly proceeding down the lateral an open/offset joint was observed and failing at the 10' mark. Pipe type is 6" clay. Clean out cap is missing. Repair completed 11-4-11

- Building 18 - Clean out cap is missing. Repair completed 11-20-11
 - Building 16 - Starting at the cleanout cracked pipe observed at 34'. Pipe type 6" clay. Repair completed 5-26-10

- Lloyd Street**
- 171 Lloyd Street - Starting at the clean out assembly proceeding down the lateral a broken/offset pipe was observed and failing at the 50' mark. Pipe type is 6" PVC. Repair completed 11-17-11
 - 211 Lloyd Street - Starting at the clean out assembly proceeding down the lateral broken pipe was observed at the 3' mark. Pipe type is 6" PVC. Repair completed 11-14-11
 - 241 Lloyd Street - PVC mount and clean out missing. Repair completed 7-25-11

- Hoover Avenue**
- 1710 Hoover Avenue - Starting at the clean out assembly proceeding down the lateral a failing 6" to 4" connection was observed with roots, leakage and an exposed gasket. Pipe type 6" PVC. Repair completed 8-8-11

- Airport Road**
- 1721 Airport Road - Starting at the clean out assembly proceeding down the lateral a broken or separated pipe was observed at the 76' mark. Camera not passable. Stop 15' to 20' from main line. Pipe type 6" PVC. Repair completed 12-16-11
