Drought Monitoring Criteria and Little Lehigh Creek Watershed Monitoring

FIGURE 3
STREAM MONITORING POINTS
Little Lehigh Creek
Watershed Monitoring Plan
Lehigh County Authority
PWSID# 3390073
Lehigh County, PA

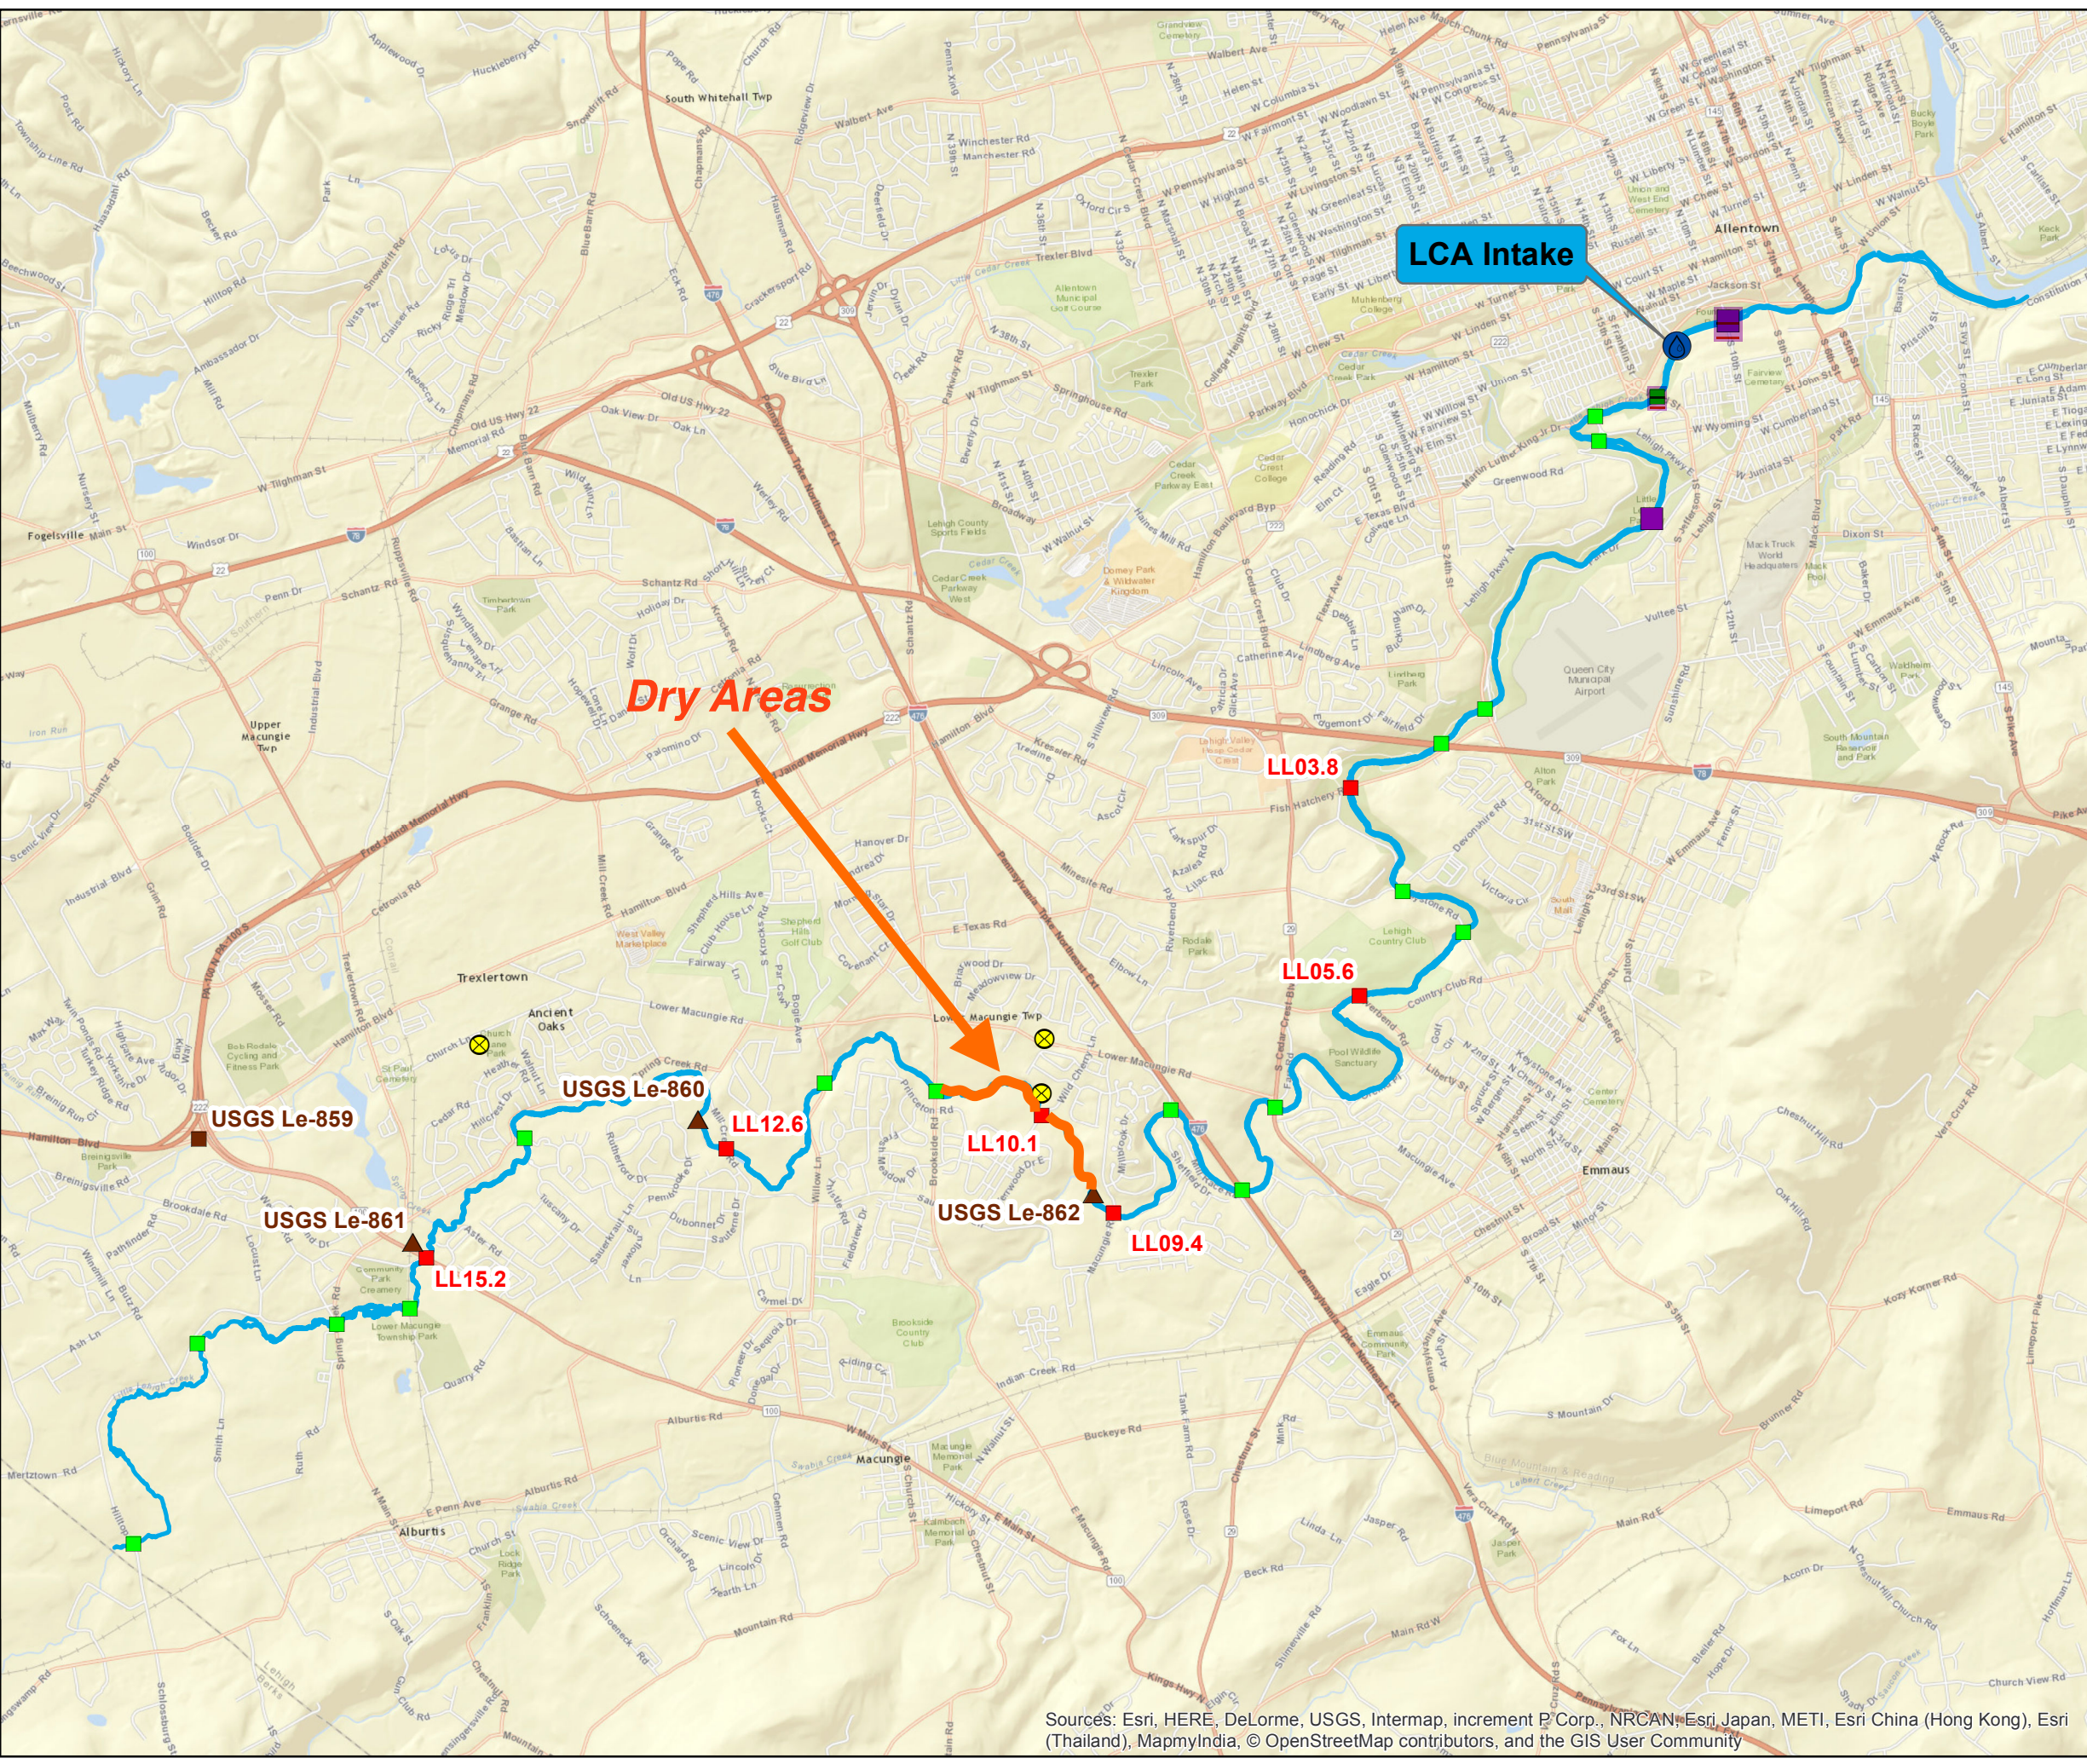
FIGURE 3
STREAM MONITORING POINTS
Little Lehigh Creek
Watershed Monitoring Plan
Lehigh County Authority
PWSID# 3390073
Lehigh County, PA

Label	Bridge	Stream Mile (upstream from LCA intake)	Drainage Area (sq mi)	Historic Site
LL03.8	Fish Hatchery Rd	3.8	80.3	
LL05.6	Riverbend Rd	5.6	75.8	
LL09.4	Macungie Rd	9.4	65.9	Station #4514.6 (USGS, 1972)
LL10.1	Wild Cherry Ln	10.1	53.3	
LL12.6	Mill Creek Rd	12.6	48.9	Station #01451420 (former USGS station)
LL15.2	Route 100	15.2	21.3	Station #4513.8 (USGS, 1972)

Label	Well Address
Le-860	1905 Pembroke Drive
Le-861	1965 Route 100
Le-862	4958 Macungie Road

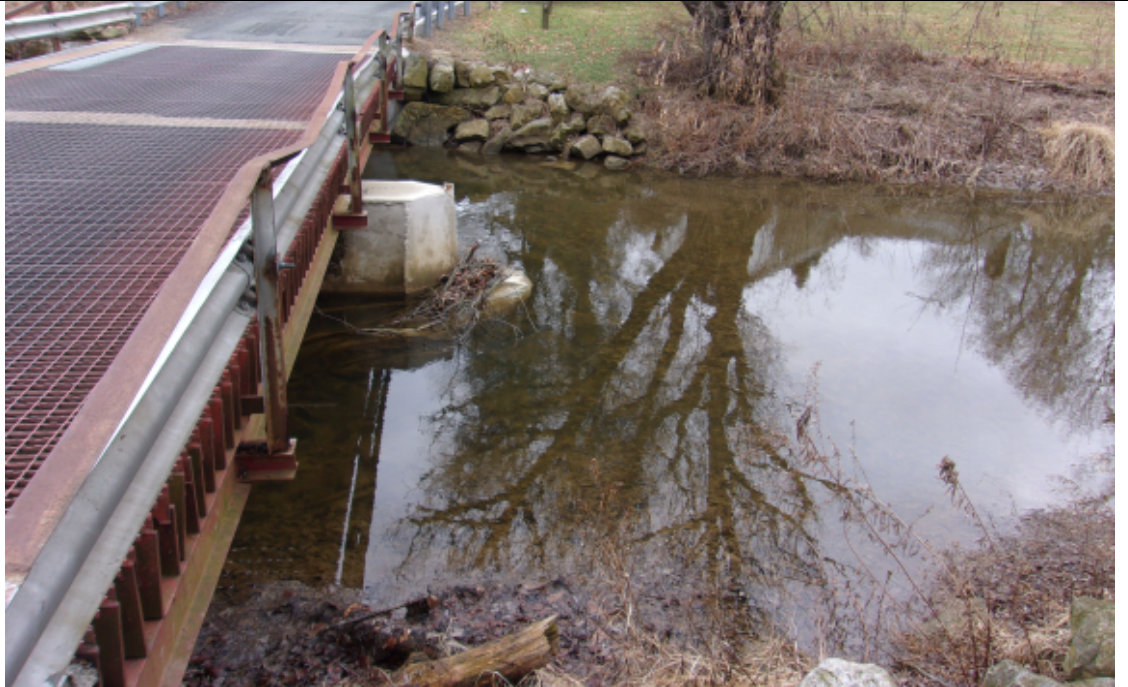
3

LL09.4 Macungie

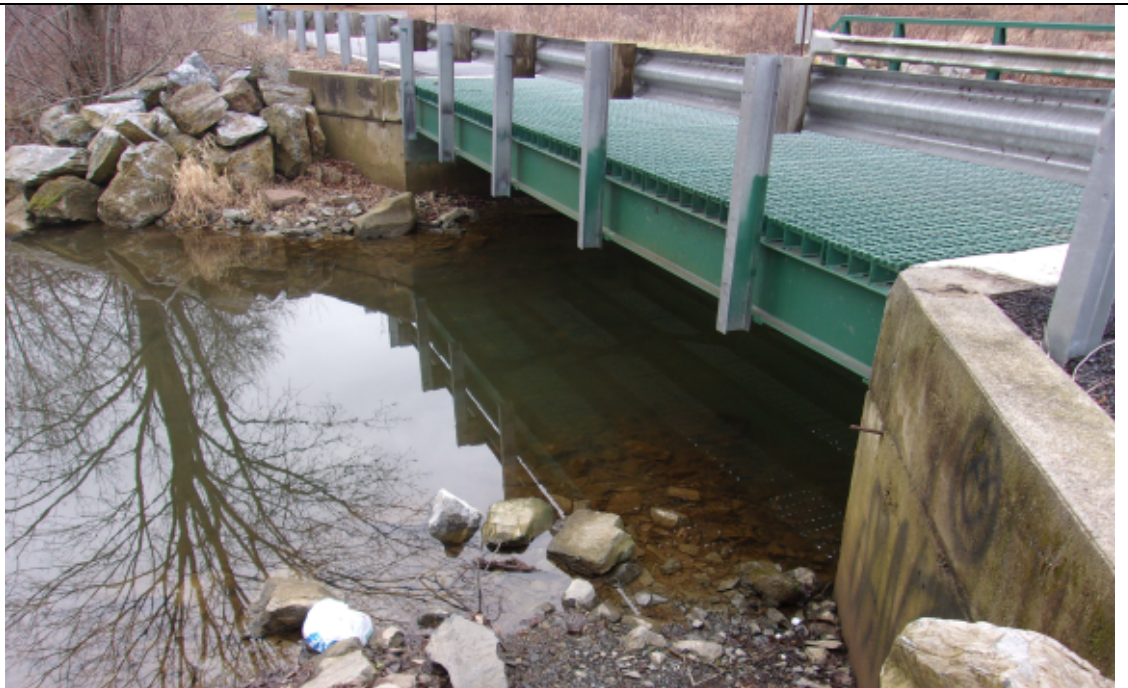
4

LL10.1 Wild Cherry
